# COMPREHENSIVE SITE PROFILE FOR CENTERVILLE – PECK INDUSTRIAL SITE

September 2011

TOWN OF RICHLAND

**DRAFT**  
**CENTERVILLE-PECK INDUSTRIAL SITE**  
**COMPREHENSIVE SITE PROFILE**

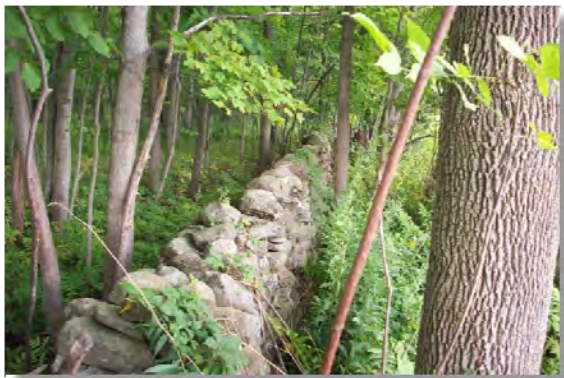
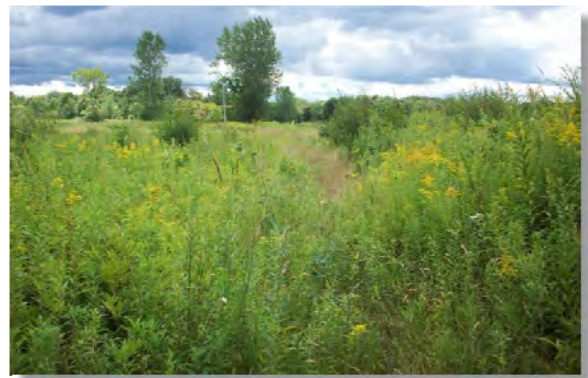
*Image 4 (left): A stone wall is located in the wooded area along the northern property boundary.  
Image 5 (right): Two drainage swales run from the northern property boundary southerly towards Centerville Road.*

Two drainage swales were observed along the trail at the northern end of the site. These drainage swales run southerly towards Centerville Road. Culverts were observed in each of these drainages and appear to drain the wooded area north of the site. No water was flowing from these drainage structures, although ponded water was observed near one of the culverts. Two additional drainage structures were observed running southwesterly through the site. These drainage swales are vegetated and did not appear to be wet.

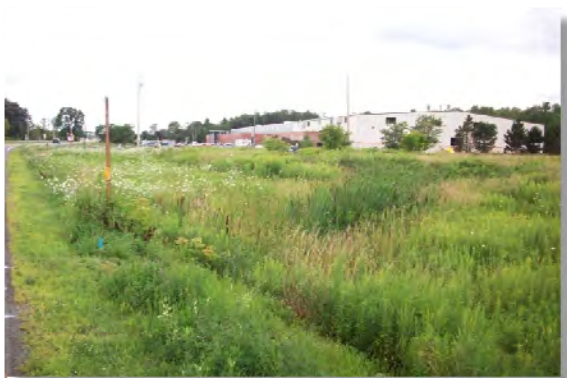
*Image 6 (left): Ponded water was observed near one of the culverts at the northern end of the site.  
Image 7 (right): A roadside drainage swale runs along the southern property boundary along Centerville Road.*

A roadside drainage swale runs along the southern property boundary parallel to Centerville Road. Culverts were observed in the swale, directing water from the swale beneath Centerville Road to off-site catch basins on the Oswego County Highway Department property south of the site. These catch basins discharge to a wet area where cattails were observed.

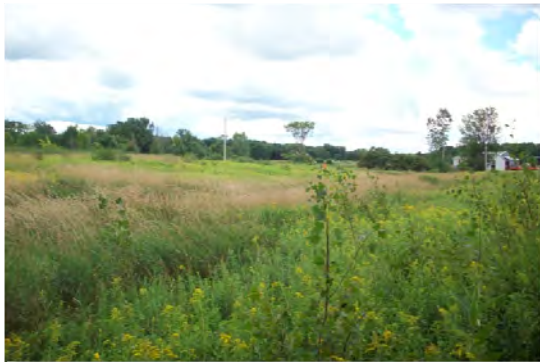
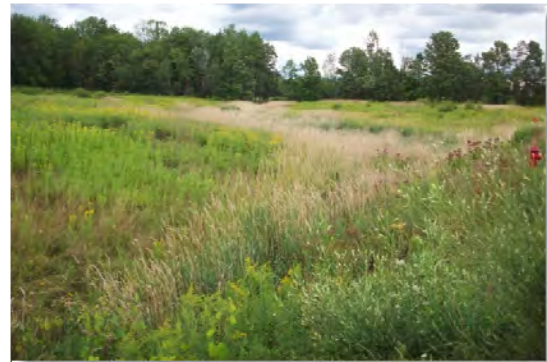
*Image 8 (left): The western drainage swale running southwesterly through the site. The drainage did not appear to be wet.  
Image 9 (right): The eastern drainage swale running southwesterly through the site. The drainage did not appear to be wet.*

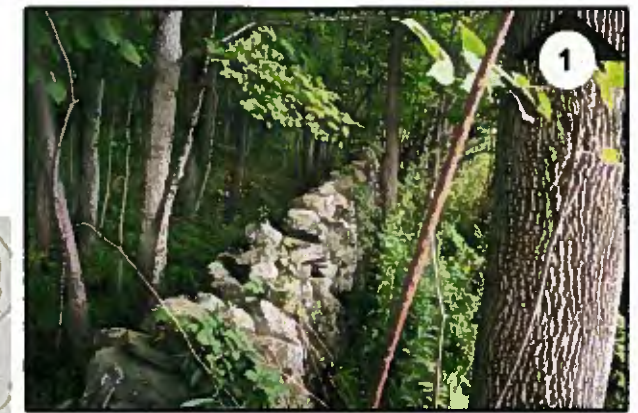
Photo 1 - Rock wall along northern property line

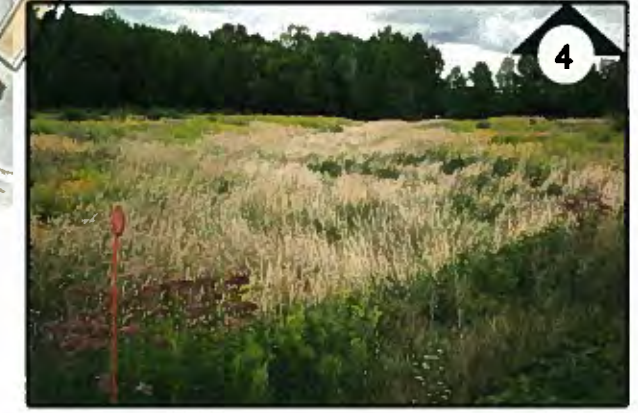
Photo 4 - Potential wetland area looking northeast
